**Development of Advanced Surface Enhancement Technology
for Decreasing Wear and Corrosion of Equipment
Used for Mineral Processing**

ANNUAL TECHNICAL PROGRESS REPORT

(July 21st, 2003 – July 21st, 2004)

DE-FC26-03NT41787

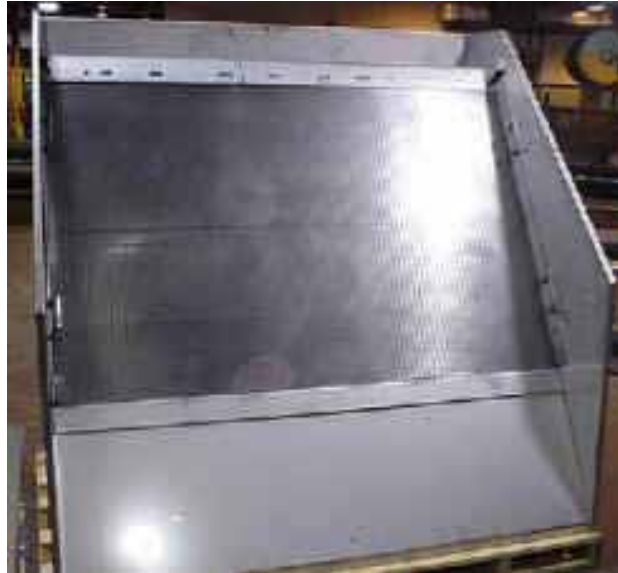
Figure 4. Sieve bend

Sieve bend (Figure 4) is another high capacity screening device widely used for fine particle ($150\ \mu\text{m} \sim 3\ \text{mm}$) classification. Coal slurry is fed tangentially to the concave surface of a sieve bend, which provides a centrifugal force that presses the feed liquid layer against the screen surface. A shaving of liquid is formed due to the centrifugal force together with a retardation of the fluid velocity next to the screen (caused by frictional drag). Therefore, the particle classification is achieved when the shaved liquid enters the open slots and reports to the underflow stream. During fine particle classification, the bar between two adjacent slots of a sieve bend becomes rounded due to wear. Most sieve bends are made of stainless steels, and the wear life of most surface screens is usually between 1,000 and 2,000 hours of operation. Frequent replacement results in high maintenance costs.

Sieve bend is constructed as an arc or bend. Wear occurs on the screen bars when feed slurry enters the bend surface tangentially. As discussed previously, sliding wear exists on sieve bend.

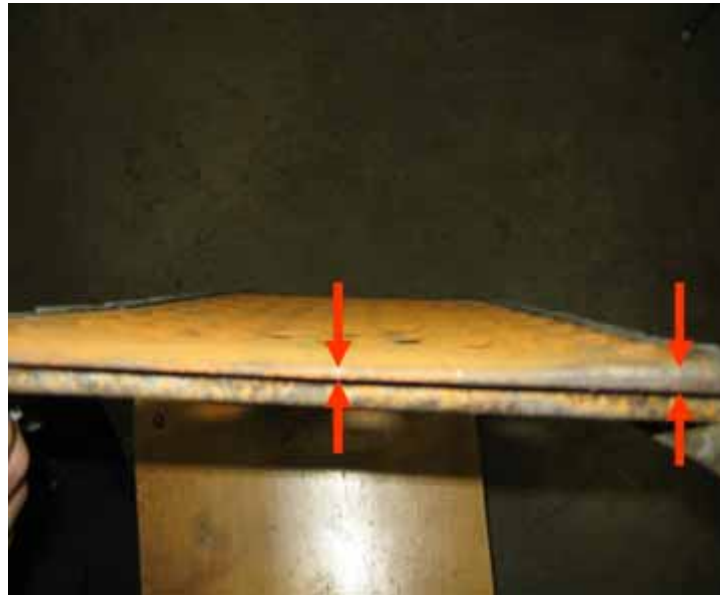
Figure 7. A replaced raw coal screen panel

Figure 7 shows a replaced steel screen panel from the Big Creek Coal Prep Plant. It can be observed that the feed end where coal contacts the screen first became very thin after a period of time. The panel could not support the load when it becomes thin. Therefore, the wear resistance of this location should be paid special attention to get extended service life. One possibility is, if surface coating is to be applied on the screen surface, a relative strong coating should be applied on the feed end. This can be achieved by changing the coating process parameters or use of different coatings on the same panel.

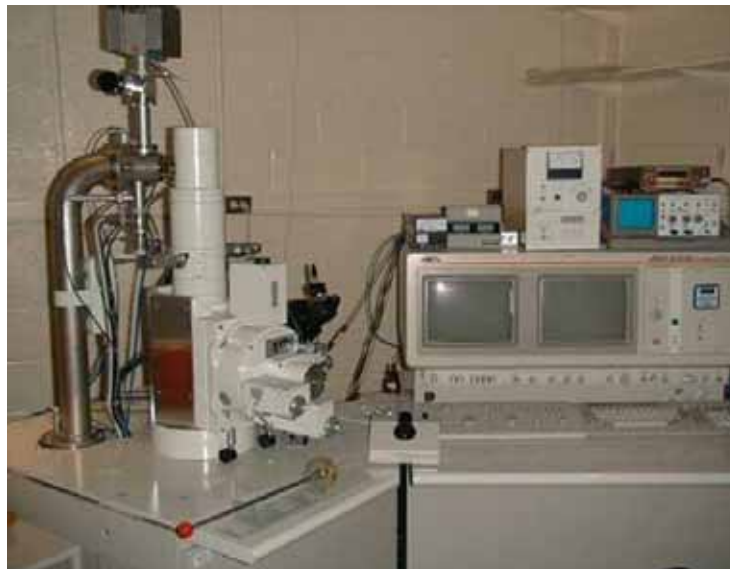
Figure 12. Hitachi S-3200 SEM

The scratch free specimen surfaces were then etched to reveal the grain structure of the metallic phases. 2% Nital (98 ml ethanol + 2 ml nitric acid) was used as the etchant. The etchant did two things to the specimen surface. First, it chemically removed the deformed thin layer on the surface which was produced during the polishing process. Second, the etchant selectively attacked the highest energy sites on the surface without affecting the others. As a result, different crystal orientations, grain boundaries, precipitates, phases and defects were showed distinctly under the microscopy for the microstructure investigation. A Hitachi S-3200 scanning electron microscope (SEM, Figure 12) equipped with energy dispersive spectroscopy (EDS) was employed to perform the microstructural characterization.
